GUARDIAN

HOME INSPECTION

123 Easy Street, Caldwell , ID
Inspection prepared for: Happy Homeowner
Date of Inspection: 8/31/2018 Time: 8 30 am
Age of Home: 1994 Size: 1023

Inspector: Jason Hopkins
License #15032205
Phone: 208-353-1820

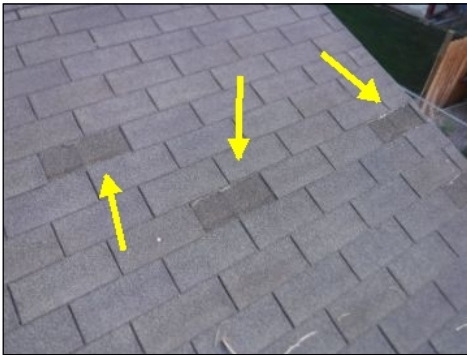
- Several asphalt shingles covering the roof of this home were missing at the time of the inspection. This condition should be repaired as soon as possible to avoid damage to the underlying home structure from moisture intrusion.

missing shingles

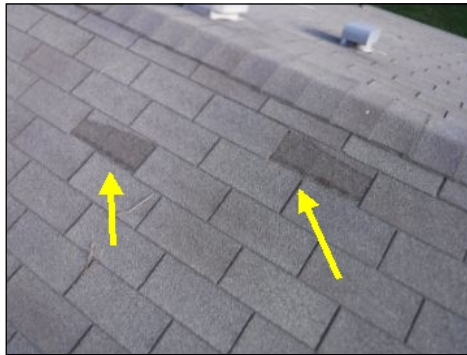
missing shingles

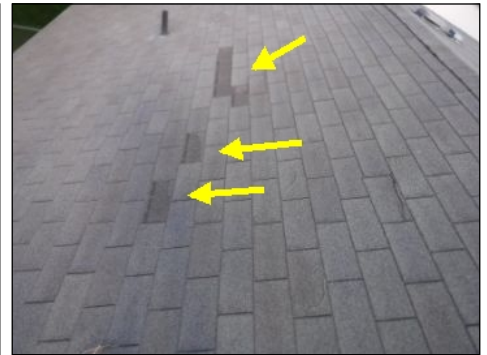
missing shingles

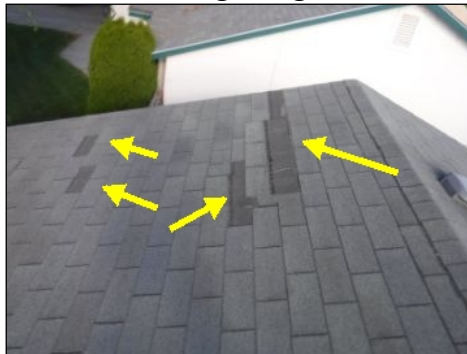
missing shingles

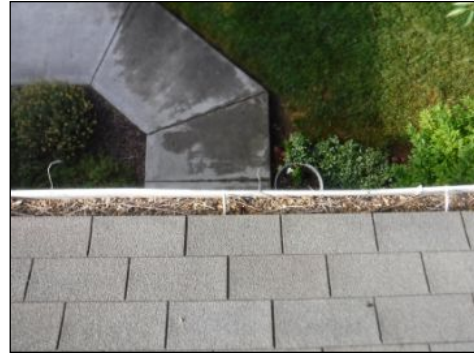
- Organic debris visible in the gutters at the time of the inspection should be removed to encourage proper drainage.

*organic debris present*

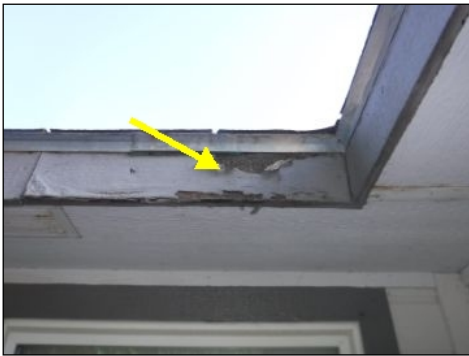
- Home fascia was damaged in places. The Inspector recommends repair by a qualified contractor.
- The fascia had peeling paint and needed maintenance at the time of the inspection.

*water damage*

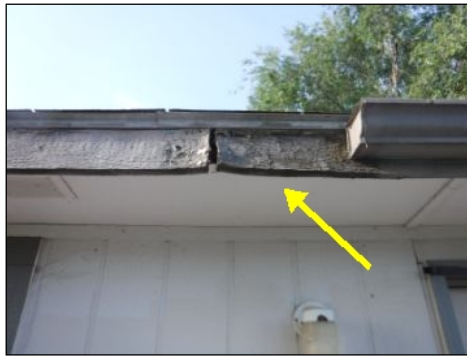
*water damage*

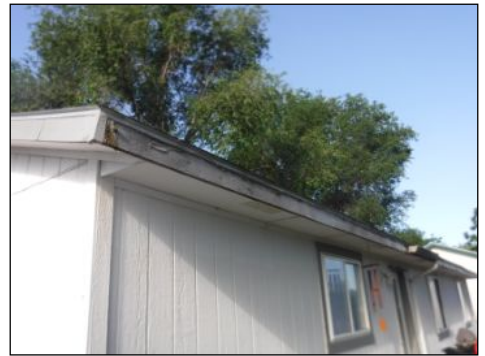
*some areas need paint and primer*

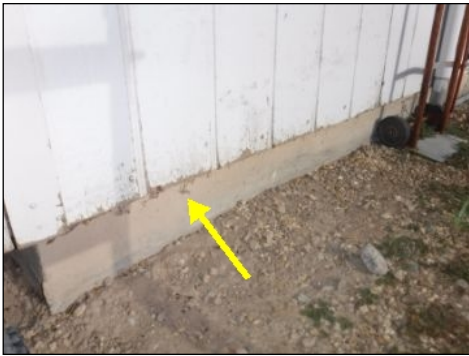
- Some areas of the siding need paint and primer.
- The trim board has water damage. The board should be primed and painted to prevent future damage.
- Vegetation has grown too close to the home. The inspector recommends pruning or removing any plants that are in contact or close proximity to the home to prevent any future damage and eliminate pathways for wood destroying insects.
- The vent cover was missing slats at the time of the inspection. The inspector recommends a cover to prevent insects, rodents or birds from entering into the home.

*some areas need paint and primer*

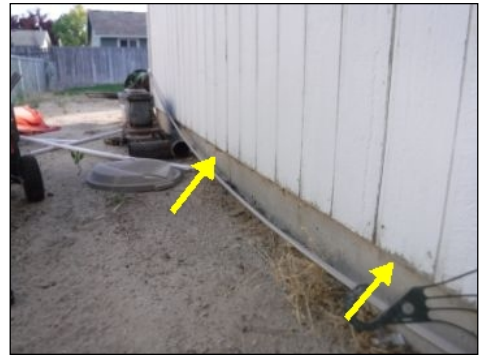
*some areas need paint and primer*

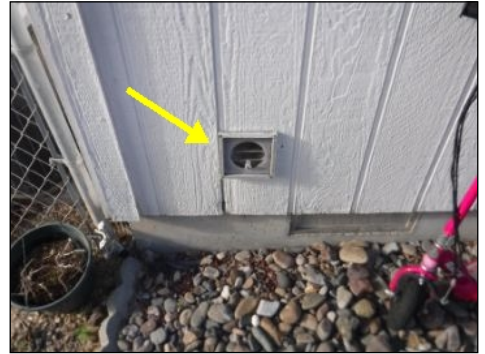
*damaged vent slats*

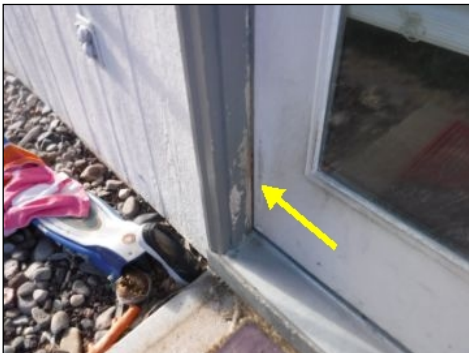
- Pet damage was noted on the rear exterior door/jamb at the time of the inspection.
- Weather-stripping on the back door was damaged at the time of the inspection.
- The sweep on the front door was missing at the time of the inspection. A sweep should be installed to help prevent heat loss which will increase heating/cooling costs and reduce home comfort. Sweeps are rubber strips which seal the area between the bottom of a door and the threshold.

*pet damage*

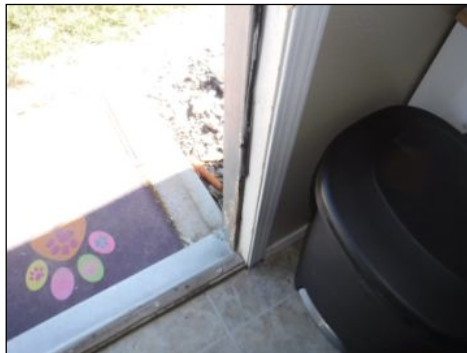
*weather stripping cracked or damaged*

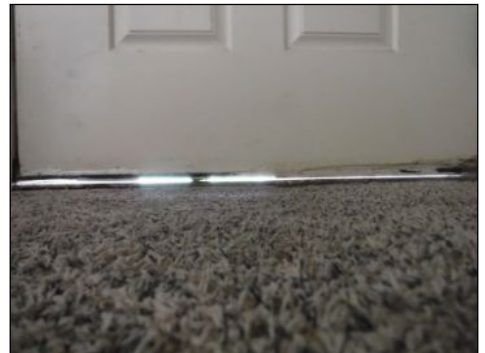
*missing sweep*

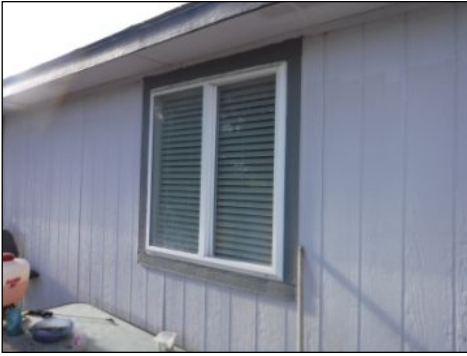
- Two window screens were missing at the rear of the home at the time of the inspection

*screen missing*

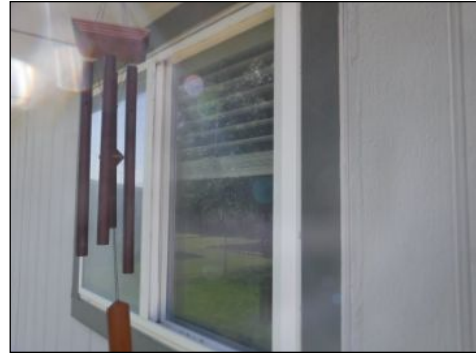
*screen missing*

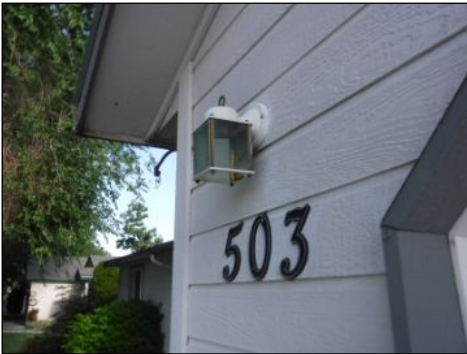
- Fixtures mounted at the front of the home were inoperable at the time of the inspection. This condition can be caused by burned out bulbs, light sensors, timers, or a problem may exist with the light fixture, wiring or the switch. You should re-test this light fixture after replacing the bulb. If after bulb replacement the light still fails to respond to the switch, consider evaluation by a qualified electrical contractor.

*light fixture may need new bulb could not evaluate*

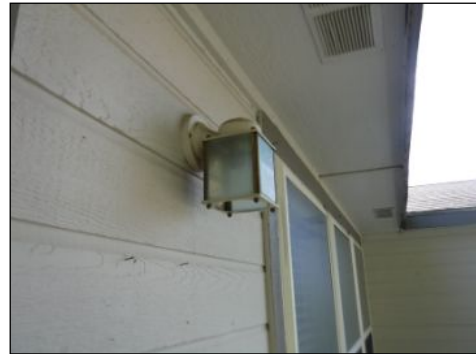
*light fixture may need new bulb could not evaluate*

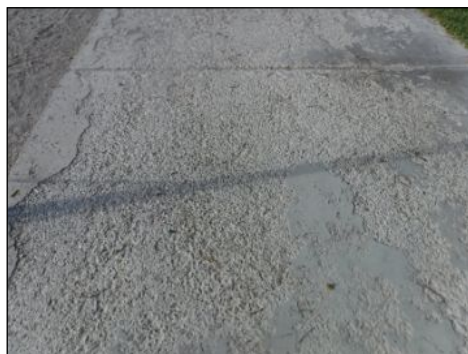
- Severe spalling or scaling was visible on the surfaces of the concrete. This condition can have a number of different causes, the identification of which lies beyond the scope of the General Home Inspection. Generally speaking this is a condition from the original pour, age, or the application of too much ice melt. The Inspector recommends patching with an appropriate material and using minimum ice melt to help prevent continued deterioration.

*spalling also known as scaling*

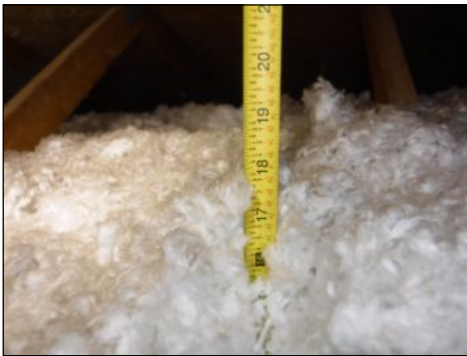
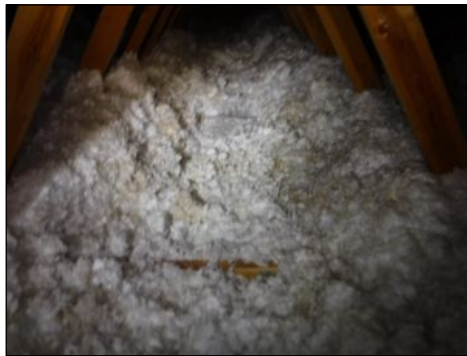
- Insulation in the attic was compacted, possibly from previous service work. The inspector recommends leveling and re distributing the insulation to promote an even coverage and a consistent thermal envelope.

insulation compressed or disturbed

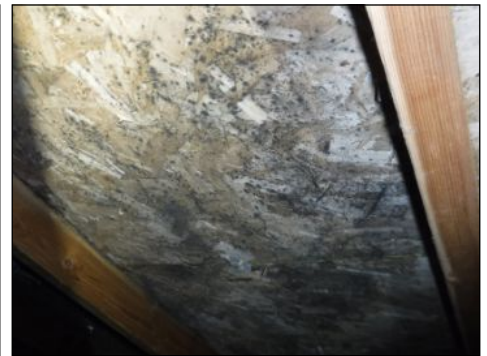
- The attic exhibited widespread discoloration that appeared to be microbial growth, possibly mold. Confirming the presence of mold would require laboratory analysis. This condition appeared to be related to excessive condensation caused by inadequate attic ventilation. The Inspector recommends further evaluation by a qualified contractor specializing in mold remediation.

microbial growth

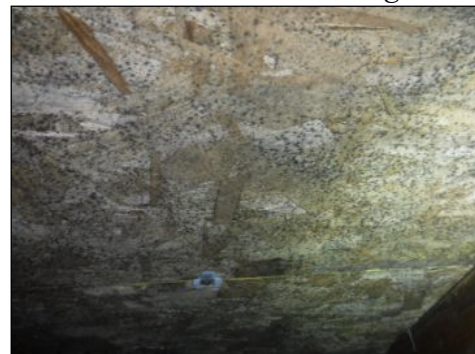
microbial growth

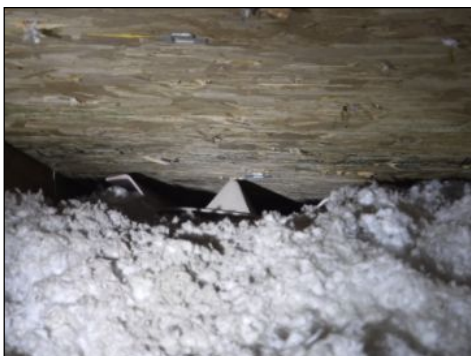
attic baffles are properly installed

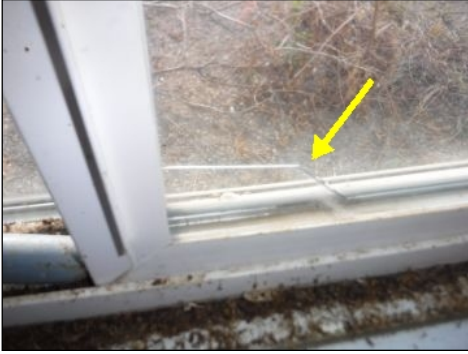
- A window in the garage had a broken pane at the time of the inspection.
- The door to the garage from the home living space needs the self-closing hinge adjusted to close automatically.
- Weather-stripping at the garage door was damaged at the time of the inspection.

broken pane

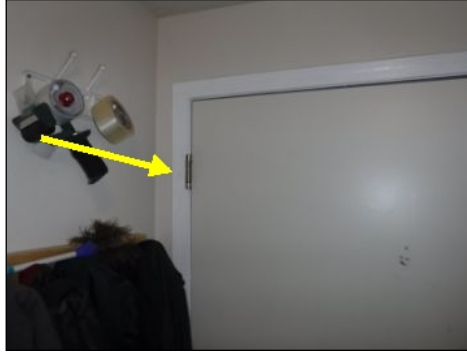
*self closing hinge on garage door
needs adjustment*

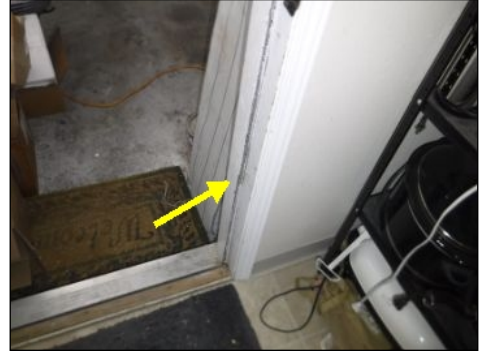
*weather stripping cracked or
damaged*

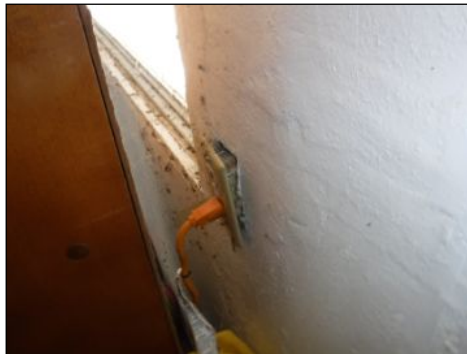
- An electrical receptacle in the garage was loose and moved when a plug was inserted. Receptacles should be securely installed to prevent fire, shock and/or electrocution hazard.

loose receptacle

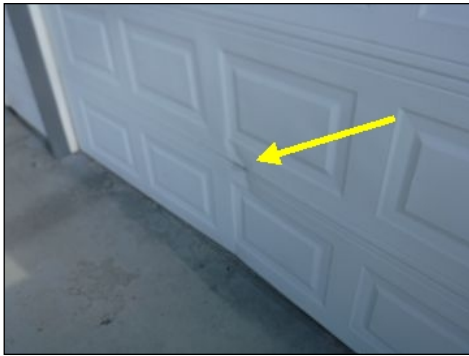
- The inspector noted minor cosmetic damage on the garage vehicle door. The vehicle door operates as intended.
- ANSI UL Standard 325 states that garage door opener must stop and re-open the vehicle door within two seconds of the door striking an 1 1/2-inch thick object placed under the center of the door. An automatic opener in this home did not meet these requirements.

damaged panel

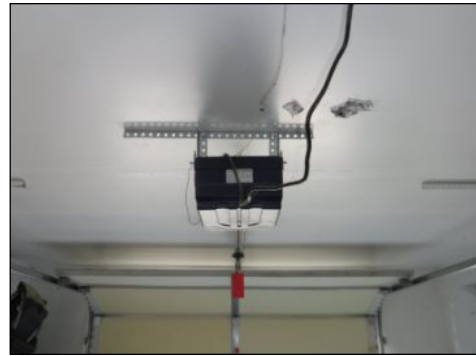
opener needed an adjustment

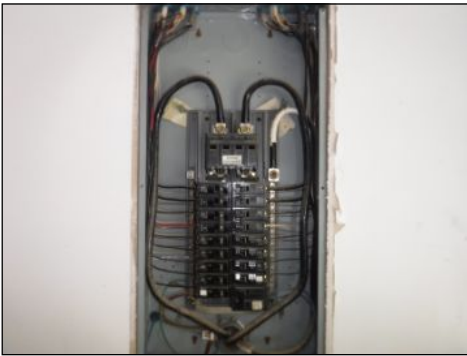
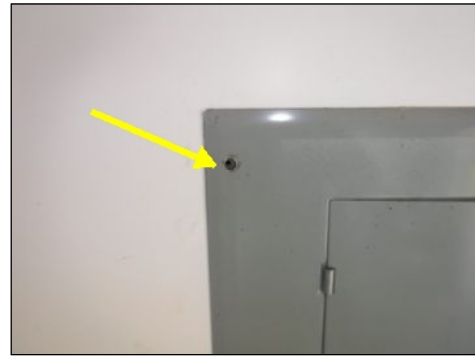
- The Inspector observed no deficiencies during inspection of the electrical panel.
- The front cover of the service panel was missing a screw. The Inspector recommends that an appropriate screw be installed to securely attach the front cover.

missing screws

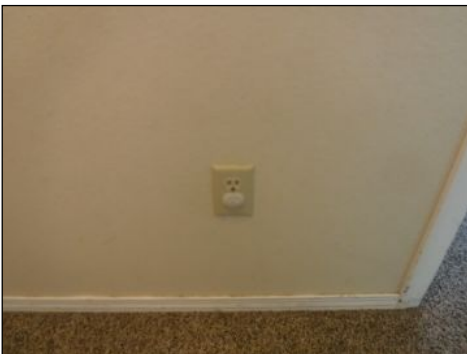
- An electrical receptacle in the hallway was improperly secured and moved when a plug was inserted. Receptacles should be securely installed to prevent fire, shock and/or electrocution hazard.
- A light fixture in the master bedroom was missing its glass covering or globe for the light bulb.

loose receptacle

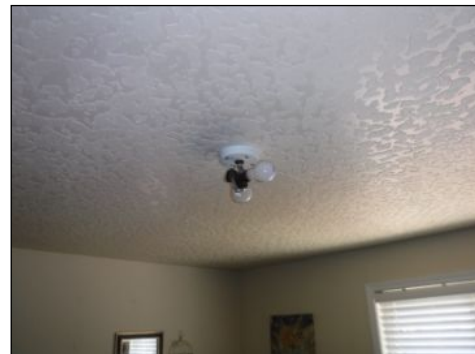
missing components

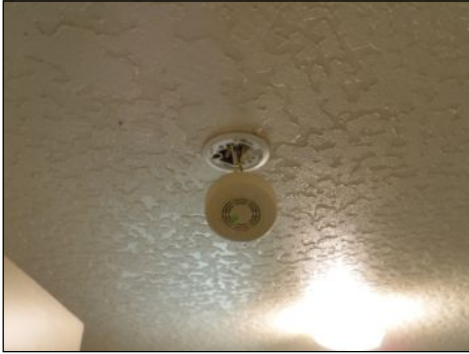
- A smoke detector was noted that hangs from the ceiling in the living room. This should be corrected for fire safety reasons.
- Smoke detectors were missing in the most of the home and should be replaced as soon as possible for fire safety reasons.

hanging from ceiling

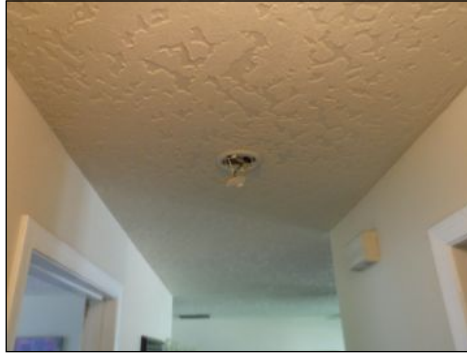
missing smoke detector

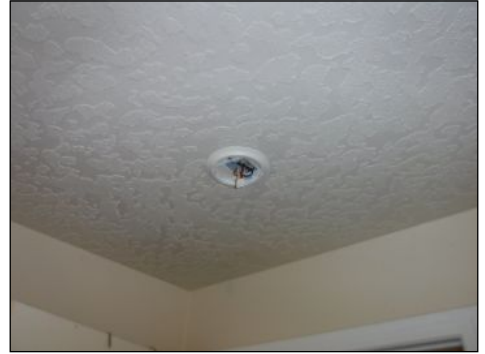
missing smoke detector

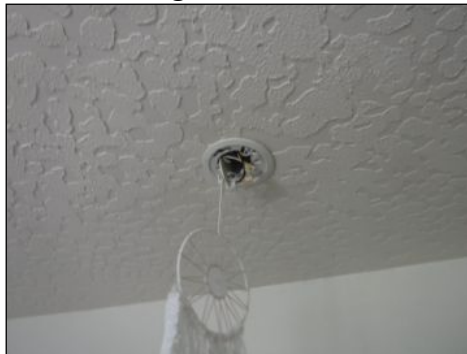
missing smoke detector

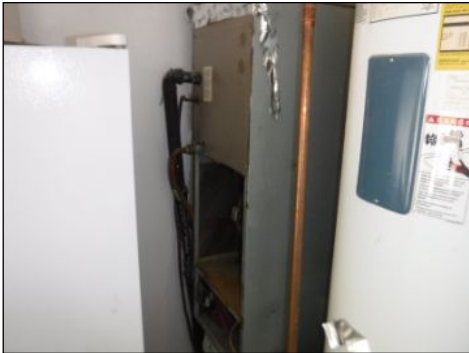
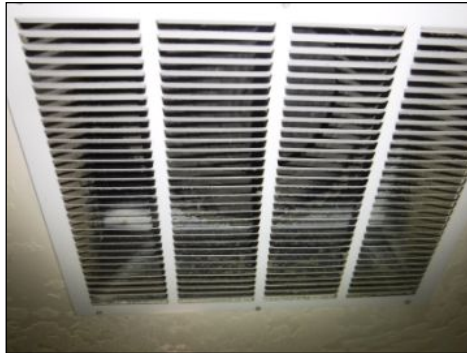
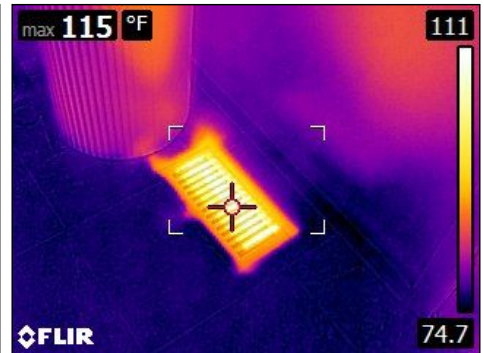
- At the time of the inspection, the Inspector observed no deficiencies in the condition of this furnace.
- There was no air filter installed at the time of the inspection.
- The thermal camera indicates that the furnace was operating as intended.

no air filter

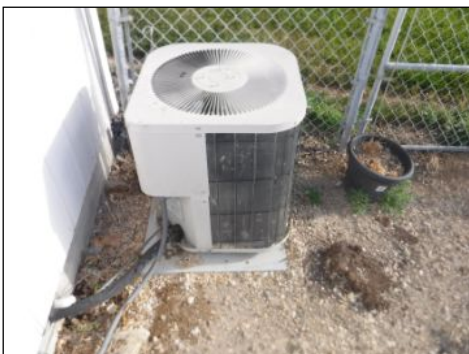
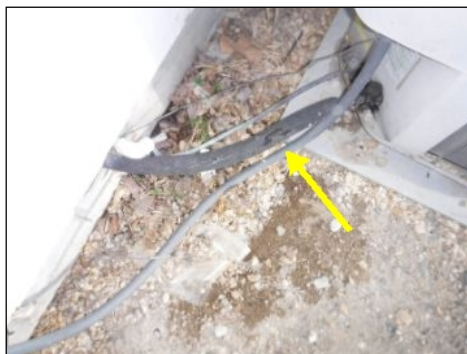
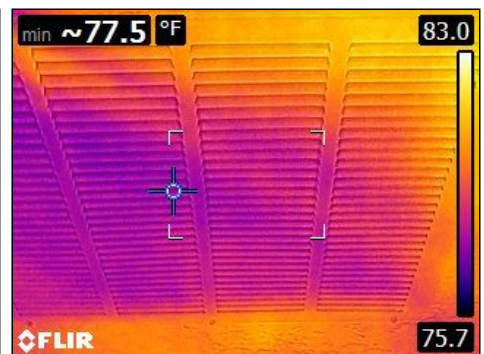
- Insulation on the air-conditioning suction (large, insulated) line was damaged or missing at areas and should be replaced.
- The thermal camera demonstrates the differences in air temperature measured at the supply and return registers that fell within the acceptable range of between 14 and 22 degrees F.

damaged insulation

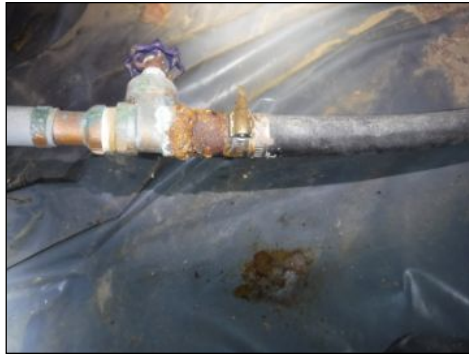
- The main water shut off was corroded and had visibly leaked in the past. The inspector recommends further evaluation by a qualified plumbing contractor,

corroded fitting and past leaking

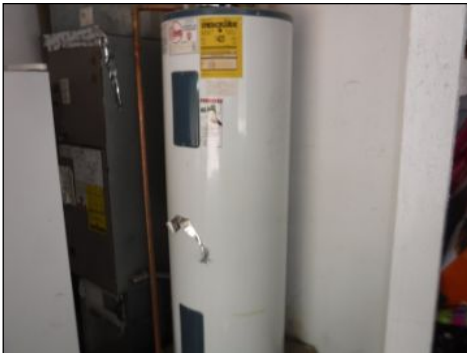
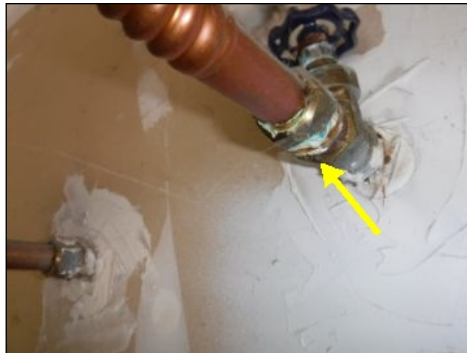
- The inspector noted mineral build up around connections at the water heater. This area may; have already been repaired, need the connection tightened, or it may be the early sign of a water leak. The inspector recommends monitoring further or repair.

mineral deposit dry

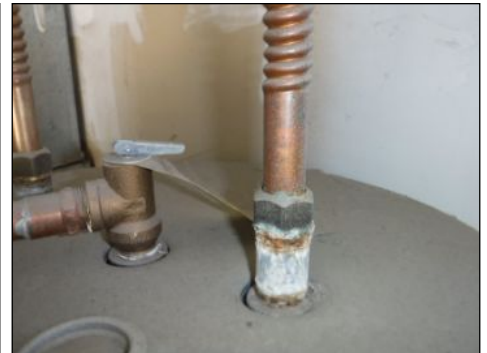
mineral deposit dry

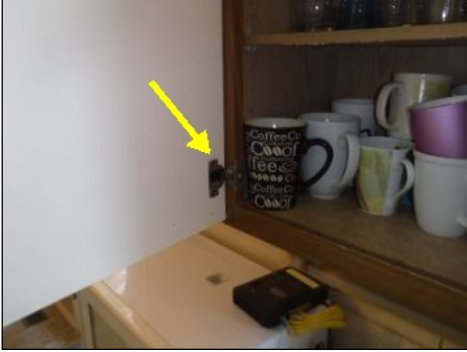
- A kitchen cabinet had a loose door hinge.
- The cabinet door does not close properly and would benefit from an adjustment.

hinge loose

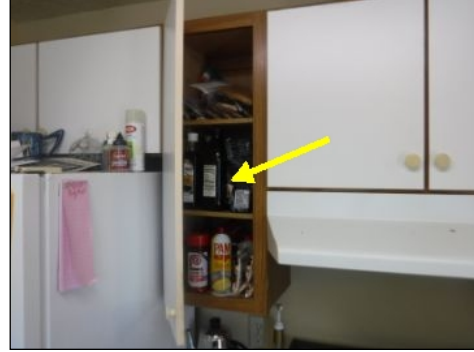
needs adjusted

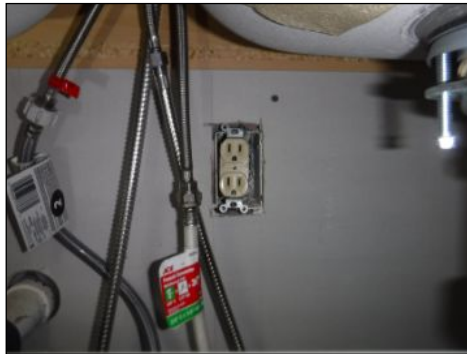
- At the time of the inspection, an electrical receptacle cover plate was missing in the kitchen under the sink. This condition left energized electrical components exposed to touch, a shock/electrocution hazard. The Inspector recommends that a cover plate be installed.

missing cover plate

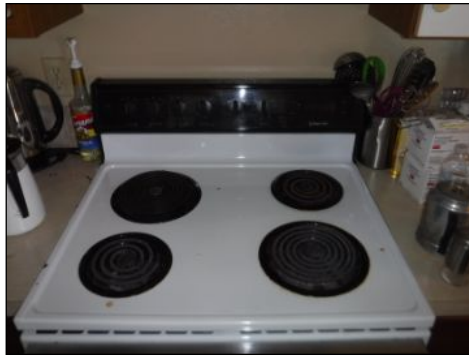
- No anti tip bracket was installed on the range. A child standing on the open oven door could overturn the range. Hardware designed to fasten ranges to the floor are available at most home improvement stores.

no anti-tip bracket installed

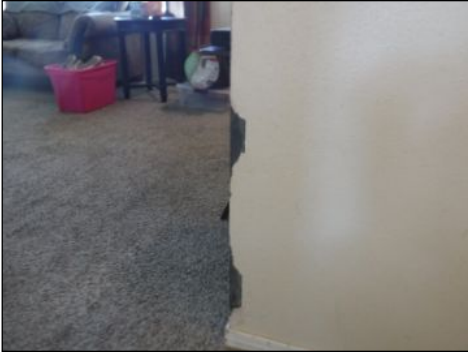
- The walls in the hallway exhibited minor damage.
- The walls in the 2nd main floor bedroom exhibited minor damage.
- The walls in the master bedroom exhibited minor damage.

minor damage

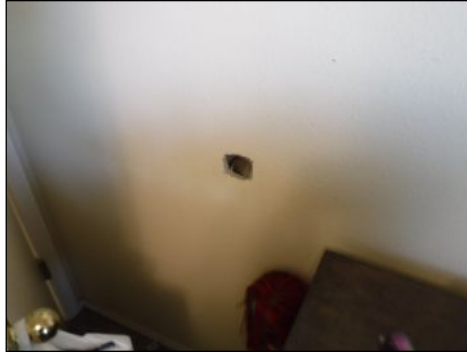
minor damage 2nd bedroom

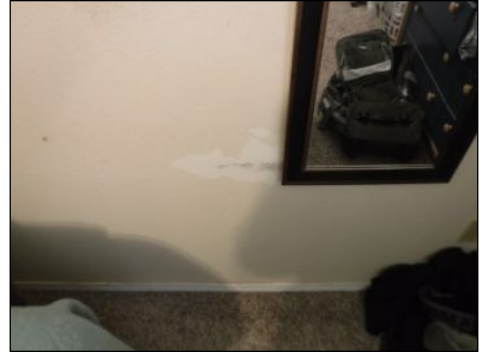
minor damage master room

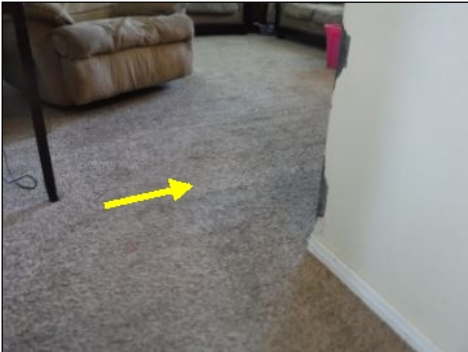
- At the time of the inspection, the carpet in the living room needed to be re-stretched.
- Carpet in the 2nd main floor bedroom had areas of staining or discoloration.

carpet needs re stretched

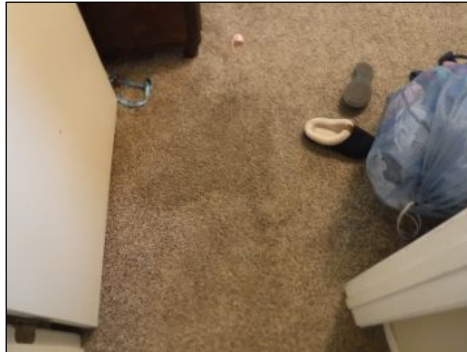
stains 2nd bedroom

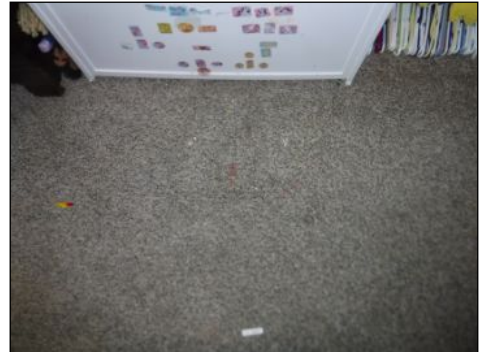
stains 2nd bedroom

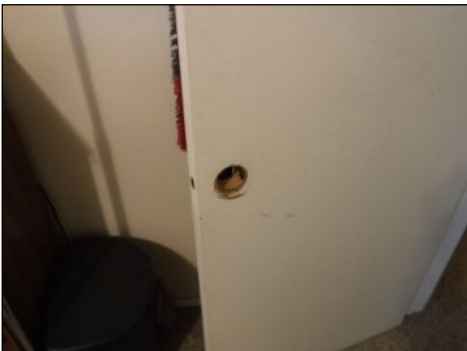
- The door knob in the master bedroom was missing at the time of the inspection.
- An interior door in the 1st main floor bedroom had loose hinges. This condition should be corrected for proper door operation and to prevent worsening damage.

missing door knob

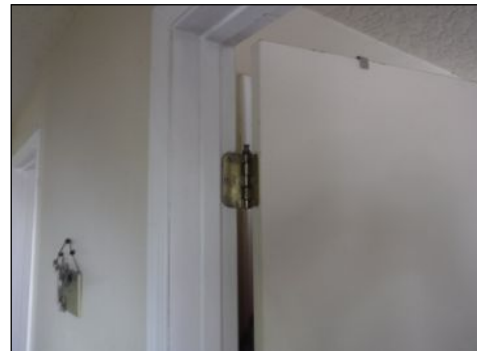
hinge - loose 1st bedroom

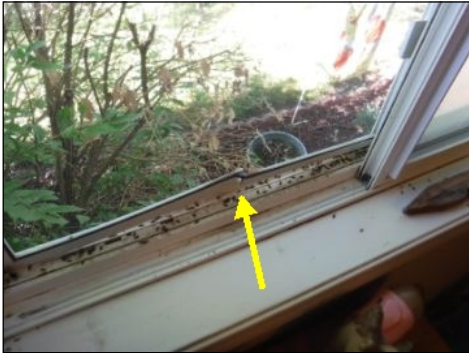
- The inspector noted a damaged window screen in the 2nd main floor bedroom at the time of the inspection.
- The windows in all the bedrooms have damaged or missing hardware and will not lock.
- The window tracks in the two bedrooms have mold or mildew and can be cleaned with warm soapy water or a mixture of bleach and water.
- Rust was visible on the interior portion of the double pane window in the 2nd bedroom indicated a loss of thermal integrity. The inspector recommends further evaluation.
- A window in the living room would come out of its track during operation. The Inspector recommends service by a qualified contractor.

screen frame damaged

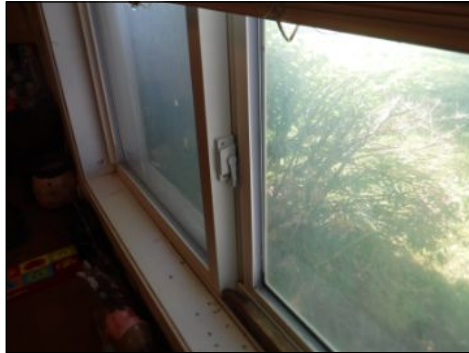
window - will not lock 2nd bedroom

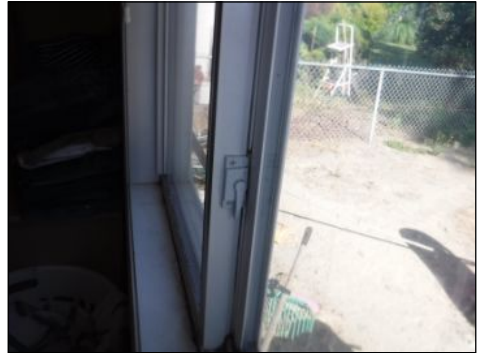
window - will not lock master room

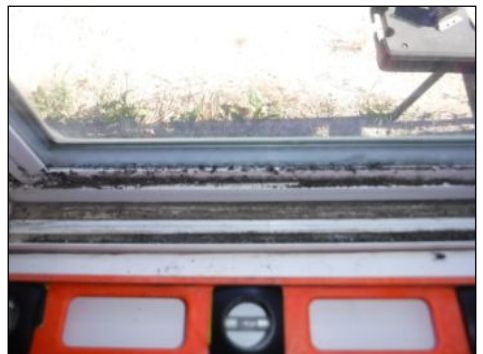
window - track needs cleaning 1st bedroom

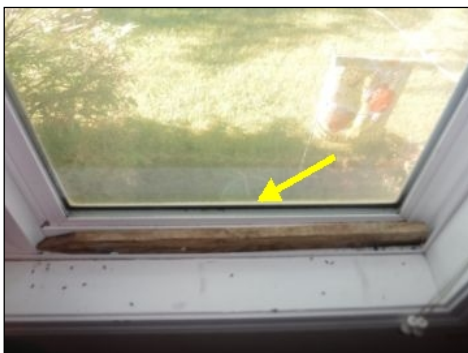
rust inside window 2nd bedroom

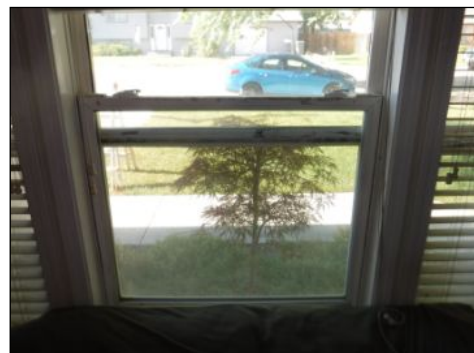
window falls out of track

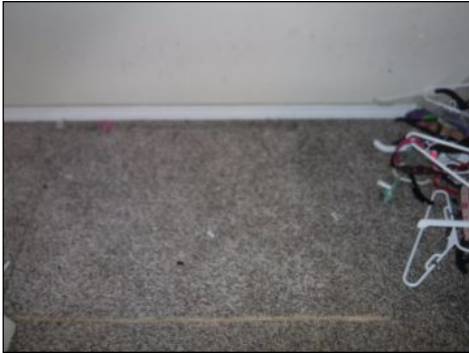
- The inspector noted the handle to lift the crawlspace access panel was missing at the time of the inspection.
- Floor joists and the subfloor in the crawlspace were covered over large areas with a substance resembling mold. Mold can only be positively identified through sampling and analysis by qualified personnel. Mold and fungi can compromise the structural integrity of wood framing members such as joists and its presence indicates moisture intrusion or a plumbing leak. Joists appeared to retain adequate residual strength at the time of the inspection. The Inspector recommends further evaluation by a qualified contractor specializing in mold remediation.

no handle

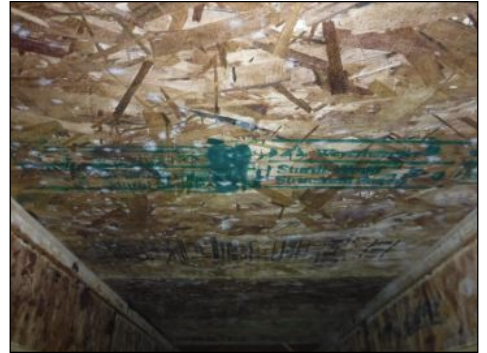
microbial growth
