GUARDIAN

HOME INSPECTION

123 Easy Street, Caldwell , ID
Inspection prepared for: Happy Homeowner
Date of Inspection: 8/31/2018 Time: 8 30 am
Age of Home: 1994 Size: 1023

Inspector: Jason Hopkins
License #15032205
Phone: 208-353-1820

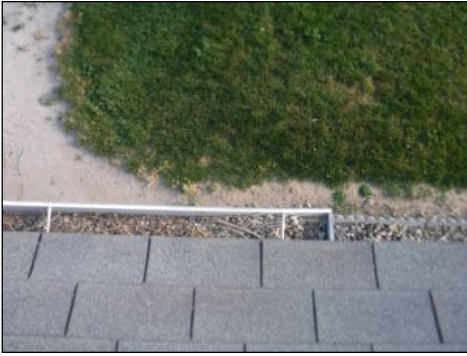
- Organic debris visible in the gutters at the time of the inspection should be removed to encourage proper drainage.

*organic debris present*

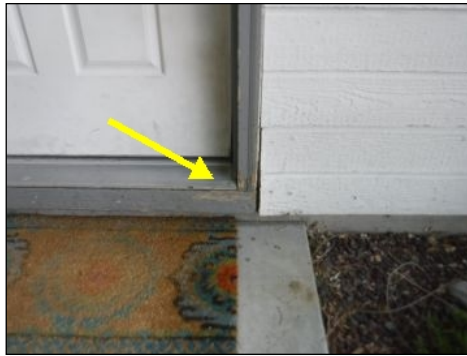
*some areas need paint and primer*

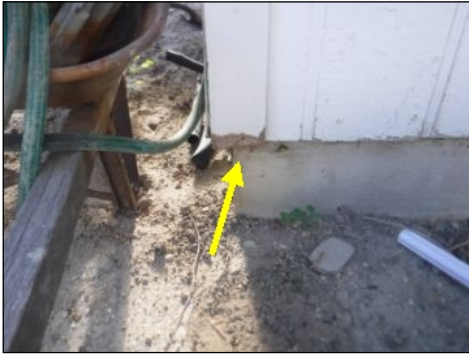
*trim board swelling from water*

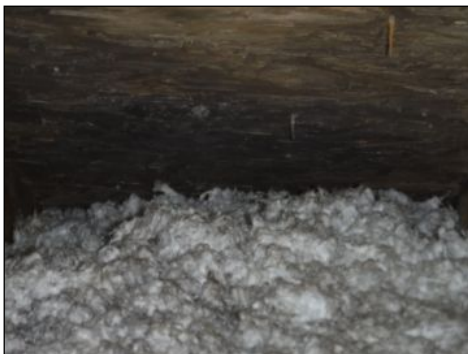
microbial growth

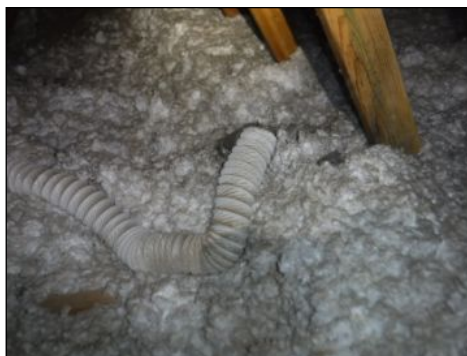
vents into attic

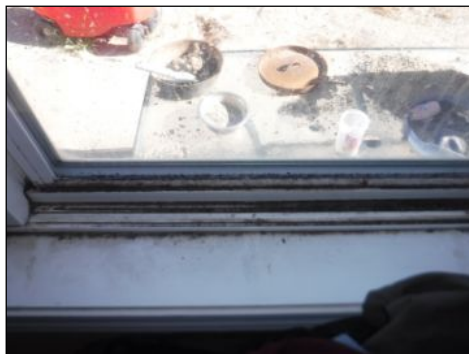
window - track needs cleaning 2nd bedroom

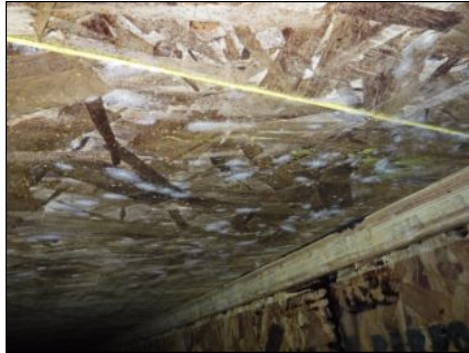
microbial growth

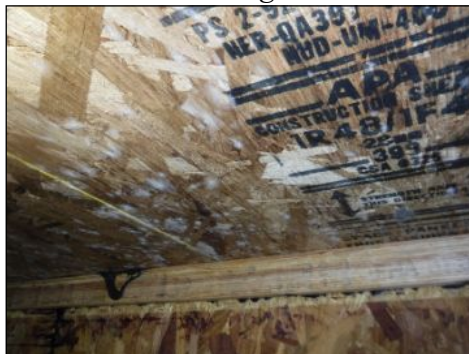
microbial growth
